SEGA GameWorks

Service Bulletin

"This Bulletin applies to the Daytona LE Games only"

Problem : No Feedback from the Steering Motor

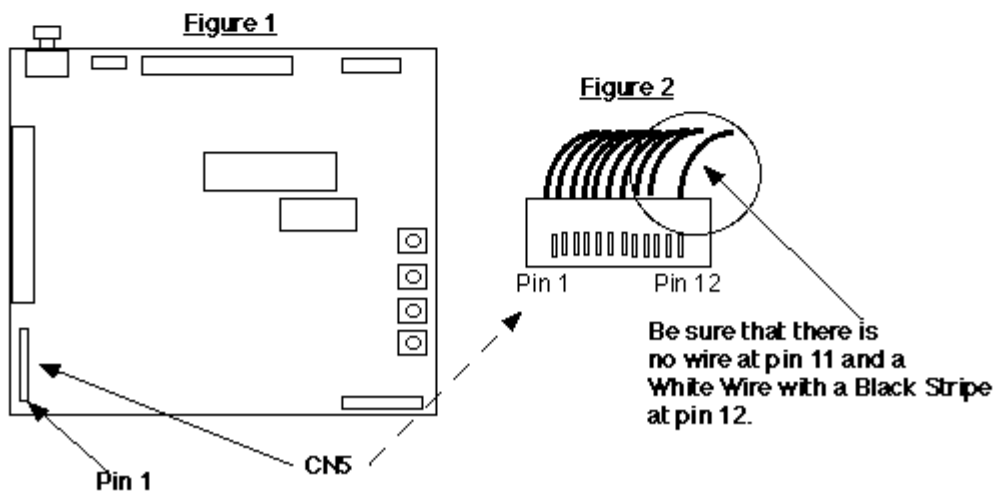
Cause : Mis-wiring of the connector at CN5 of the I/O Board.

1. Turn Power Off. Open the PC Board Cage and locate the I/O Board (837-10539)
2. Locate CN5 and unplug it from the board (See Figure 1)
3. Move the White / Black Wire from Pin 11 of that connector to Pin 12. (See Figure 2)
4. Re-install the connector , and power up your machine to verify proper operation. Close up machine.
